CASE REPORT

Percutaneous Lipiodol Lymphangiogram in Chylous Leakage Successful Embolisation Post Mastectomy: A Case Report

Malaysian Journal of Medicine and Health Sciences (2022) 18(4):221-223. doi:10.47836/mjmhs18.4.30

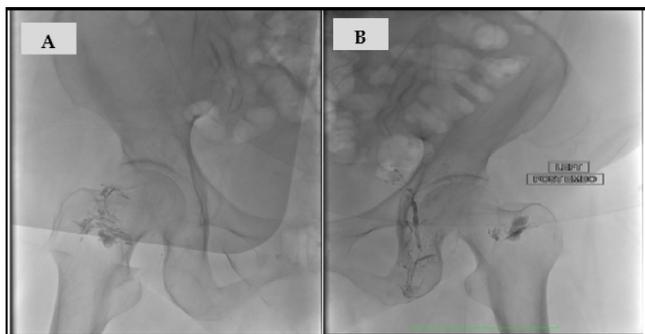
Figure 1: (A) Showed Lipiodol injection into the right inguinal lymph nodes while Figure 1(B) Showed injection of Lipiodol into the left inguinal nodes. Note that contrast opacify lymphatic network at the left inguinal region.

The desired area was cleaned and draped. A total of 5 mls of Lipiodol was injected under ultrasound guidance into the lymph nodes at the bilateral inguinal regions (Figure 1), (2.5 mls on each side) at the rate of 1 ml/minute. Dissemination of lipiodol was monitor under intermittent fluoroscopic screening.

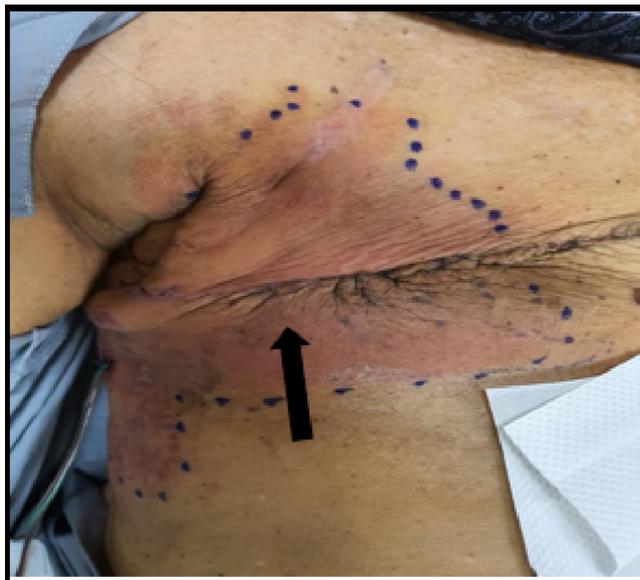
Figure 3: Day 2 post injection Lipiodol, patient developed skin erythema (black arrow) at the lateral aspect of the right mastectomy site. She was also having fever hence, surgical team treated as cellulitis. It resolved after 4 days of antibiotics.

Noteworthy, we also noted that 48 hours of post procedure, the patient developed a skin erythema at the surgical site with fever (Figure 3). Patient was covered with antibiotic for infection. It was resolved after 7 days with antibiotic treatment. The patient visited the surgical clinic 1 week after discharge. She was well with no new collection over the right axillary region.

Another aspect to be considered is possible side effect of direct lipiodol injection into the collection. Our patient developed skin erythema after 48 hours post lipiodol injection. Although, it was treated as skin infection by primary team, one must bear in mind that the risk of allergic or adverse reaction is possible with lipiodol injection.

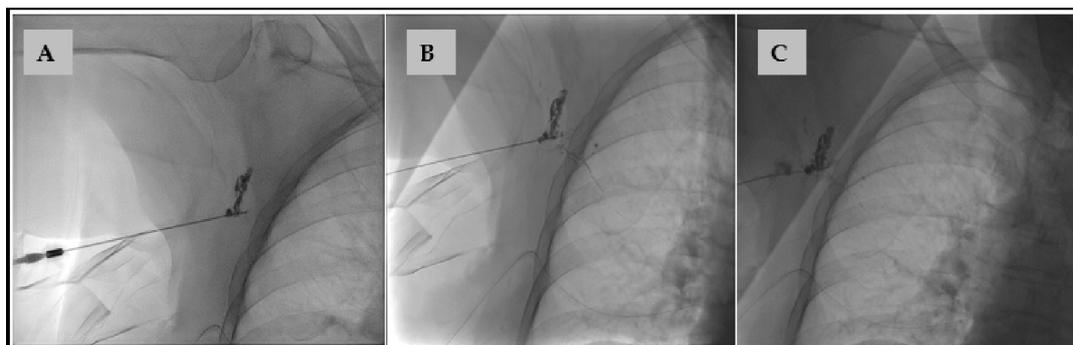
Figure 2: (A) showed initial injection of Lipiodol into the collection at the right axillary pouch. (B) Showed propagation into the lymphatic network at the right axillary region and over the right mastectomy site. (C) Showed final fluoroscopic image after 5mls of Lipiodol injection.

The remaining 5 mls Lipiodol was injected into the right axillary collection and monitored under intermittent fluoroscopy (Figure 2). From the fluoroscopy monitoring, the injected Lipiodol was seen propagated into the lymphatic channel. Post procedure, we put compressing bandage at the surgical site to give tamponade effect onto the right axillary collection.
