CASE REPORT

Challenges in Managing a Fractured Cement-retained Crown Located at the Aesthetic Zone: A Case Report

Implant prosthesis is a popular treatment modality but it is not complication free. This article discussed the management of a cemented, all-ceramic implant crown in the maxillary anterior region that had veneering ceramic fracture after three years in function. A screw-retained prosthesis was prescribed to avoid the show of the screw access channel on the incisal edge of the crown. This was achieved by changing the location of the screw hole using the angle screw channel that overcame the angulation issue.

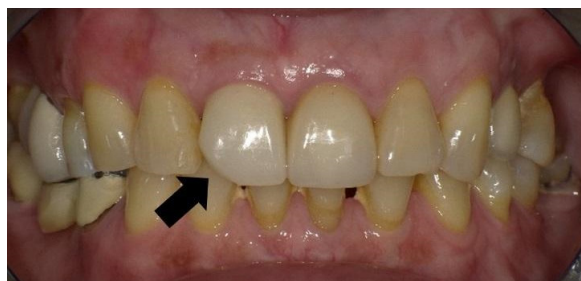
Fig. 1 Chipped veneering ceramic which has been repaired with composite using a porcelain kit. However, it only lasted for six months after two attempt of repair.

A 60-year-old female presented for extraction of tooth 11 followed by immediate implant placement in 2015 (TS III SA, Osstem, South Korea) followed by immediate loading. The last prosthesis was a cement-retained porcelain-fused to zirconia (PFZ) crown on a customised computer-aided design and manufactured (CAD/CAM) titanium abutment. After two and a half years in function, the patient returned with the complaint of the implant crown chipped off as she accidentally bit on a nut (Fig. 1). She was not keen to have a new crown made and opted to have a direct repair done. As a reliable resin bonding was not expected to be achieved with zirconia material, retention grooves were prepared and direct repair was carried out with composite material as a provisional measure (Fig. 2). Four months later, she came back with the same complaint and clinical examination noted that the composite material that was used to repair

the crown has dislodged. Another repair with composite was attempted. However, it only lasted for about two months. The patient finally was convinced that a new implant crown was needed and consented to have the implant crown remade.

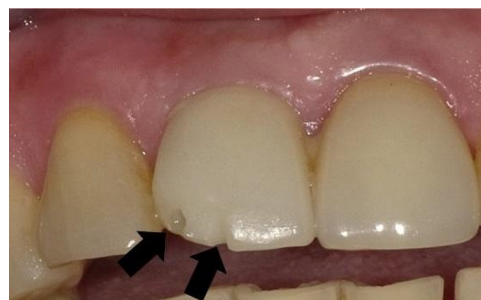
Fig. 2 Retention grooves were prepared to aid in composite retention.

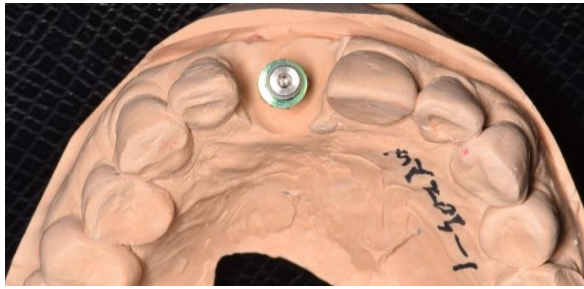
Fig. 3 Implant axis was assessed on the working model.

The implant axis was assessed and determined through the working model that was prepared for implant crown fabrication made in the year 2015 (Fig. 3). This allowed a screw hole to be located and accessed accurately using a coarse grit diamond bur (Meisinger, Germany), however it has caused unavoidable damage to the crown as this access was located on its incisal edge (Fig. 4). As the patient was satisfied with the emergence profile of the crown, the impression coping was modified with a flowable composite to capture the soft tissue profile so that the dental technician was able to copy the contour (Fig. 5). The impression coping was then picked up with polyether material (Soft Monophase, 3M ESPE) (Fig. 6).

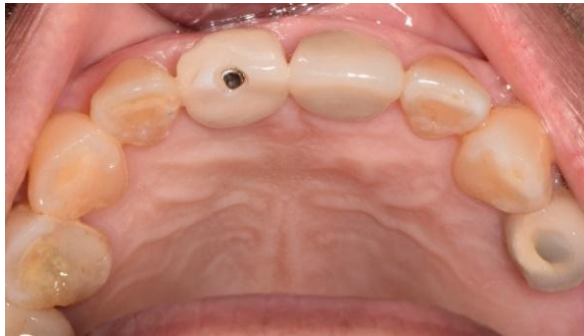
Fig. 4 Accurate access to abutment screw that was located directly over the incisal edge of the crown.

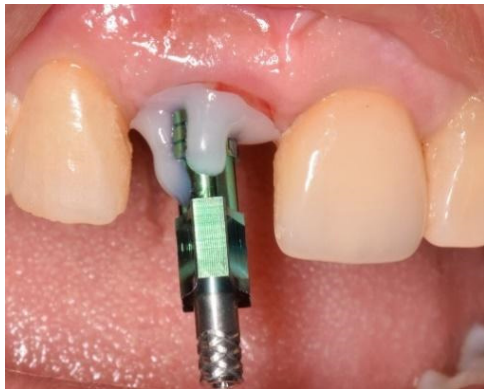
Fig. 5 Modified impression coping to capture the soft tissue profile.

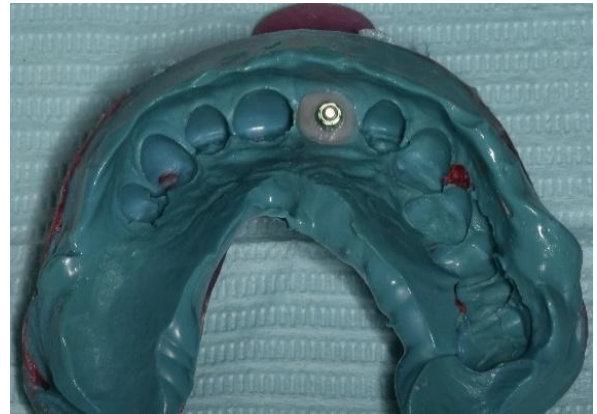
Fig. 6 Modified impression coping was picked up in the impression.

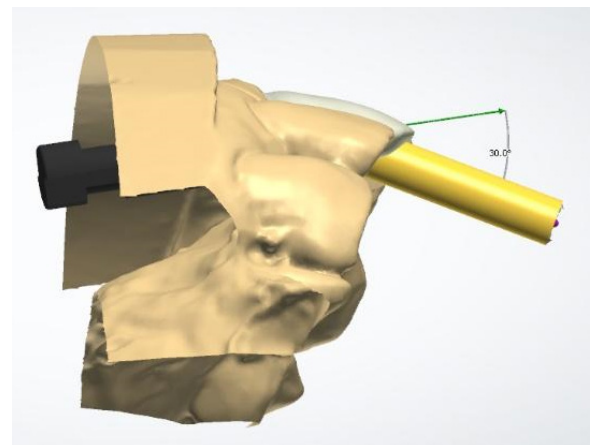
Fig. 7 Digital design of the crown indicating 30 degree of angle correction was required to bring the screw access channel palatally.

A decision was made to convert the cement-retained prosthesis into a screw-retained prosthesis by using an angle screw channel abutment to facilitate future maintenance work, and to facilitate crown removal in case of porcelain fracture. Titanium base abutment with angle screw channel (Dynamic TiBase®, Dynamic Abutment® Solutions, Lleida, Spain) was used for the new prosthesis. The working model

was scanned with the scanbody (Dynamic Abutment Scanbody, Dynamic Abutment® Solutions, Lleida, Spain) and the final prosthesis was designed with CAD software (Dental System™ 2017 Premium, 3Shape, Copenhagen, Denmark). The CAD image showed the amount of angle correction that was needed in order to bring the screw access channel palatally for a screw retained prosthesis. (Fig. 7). The metal coping was then prepared by milling with a 5-axis milling machine (Zenotec select hybrid, Wieland Dental, Ivoclar Vivadent Group). A metal-ceramic prosthesis was then fabricated for a direct to implant, screw-retained crown (Fig. 8).

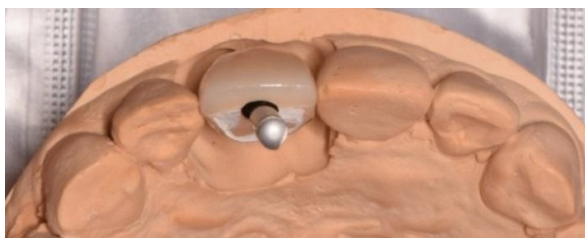
Fig. 8 Direct screw access with the implant driver.

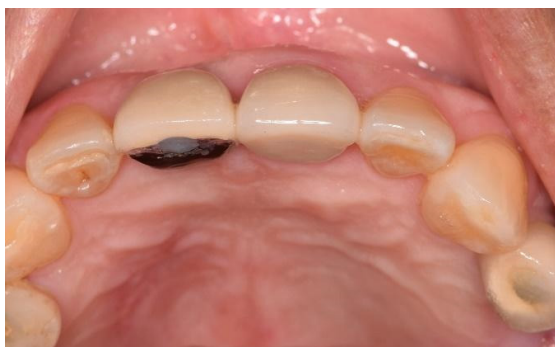
Fig. 9 The implant crown was inserted and screwed, followed by sealing of the access hole with composite.

During insertion visit, the screw-retained implant crown was tried-in for aesthetic and occlusal adjustment. The implant was then inserted and torqued to 25N/cm using the Dynamic screwdriver. This was followed by packing of polytetrafluoroethylene (PTFE) tape to protect the screw head and the screw access hole was sealed temporarily with a temporary cement (IRM, Dentsply Sirona). Subsequently, a review appointment was carried out before the screw access hole was sealed with a bonding agent (One Coat 7 Universal, Coltene, Switzerland) and resin composite (Fig. 9 and Fig. 10).

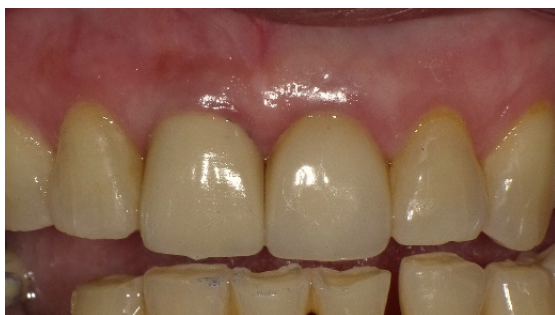
Fig. 10 Labial view of the implant crown; note the cervical contour of previous crown was copied.
