CASE REPORT

Full Mouth Rehabilitation of Failed Implants Prosthesis: A Case Report

Management of implant failures is difficult, especially implant fixture fracture where it is complicated and requires multispecialty care. The aim of this report is to describe the challenges of treatment planning and management of implant fixture fracture with tooth wear on patient with financial constraints. A 67-year-old retired male patient came to the dental clinic with a complaint of a mobile implant-supported fixed prosthesis, fractured implant fixture and attrited lower dentition. Treatment plan was planned around low cost with the biggest benefit of the patient. Multispecialty care is involved such as root canal treatment, implant removal, restoration of remaining dentition and replacement of missing teeth with removable prosthesis. The patient was reviewed after a month of completing full treatment resulted in a good treatment outcome. Lack of maintenance regimen leads to failure and mobility of the implant prosthesis. Proper maintenance protocol, post-insertion instructions, and good patient compliance are the key factors in determining longevity of the restoration.

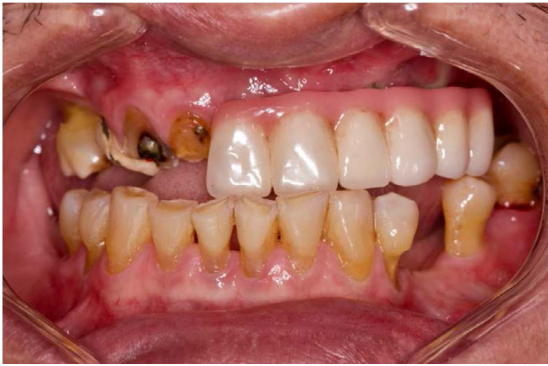
Basic clinical examination was done for the patient. A clinical (Fig. 1), radiographic examination (Fig. 2) and diagnostic cast of the lower arch (Fig. 3) revealed generalised mild tooth wear (combination of attrition and abrasion), a mobile implant-supported fixed denture on teeth 11 to 25, a complicated fractured crown on teeth 12 and 13, generalised attrition, abrasion on teeth 34, 44, and 45, Glickman furcation grade II on teeth 16 and 37, mandibular Miller grade II gingival recession, peri-implantitis on teeth 11 to 25 and generalised periodontitis stage III grade A. Oral hygiene of the patient was fair. Further periodontal examination was carried out to measure the pocket depth, clinical attachment loss, recession, furcation, and mobility of the remaining teeth.

Fig. 1 The oral condition of the patient during the first visit.

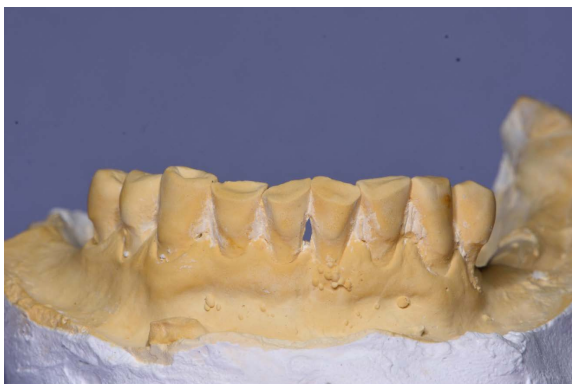
Fig. 3 Lower diagnostic cast of the patient.

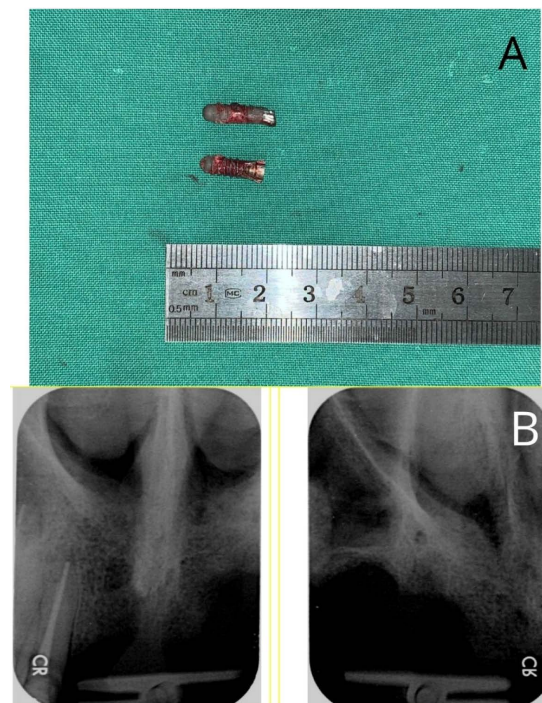
**Fig. 5** (A) Both fractured implant fixture was removed surgically while (B) revealed the radiograph of post explantation of both implants.

Composite (SDI Luna Composite, SDI, Australia) was used to restore the teeth 12, 13 and 14 after endodontic treatment. Next, a trapezoidal flap was raised and surgical removal of implant fixture on teeth 11 and 23, together with extraction of 35 was carried out using a trephine kit (Dentium, Implantium Malaysia Sdn Bhd) and extraction forceps (Fig. 5). Tooth 35 was extracted due to poor crown-to-root ratio and mesially rotated with a lingual undercut, therefore cannot be used as a denture abutment as guiding plane preparation on the lingual of tooth 35 needed to be done to ease the path of insertion of the lower Partial denture. Absorbable collagen hemostat (Collacone®, Botiss Biomaterials, Neodent, Germany) was mixed with the patient's blood and placed in tooth sockets 11 and 23. The flap was repositioned back and sutures were applied. After 10 days, the patient returned for suture removal and uneventful healing of the surgical site was observed. The patient was scheduled to be recalled after one month for stable bone and tissue healing before proceeding to Phase II Part 2.

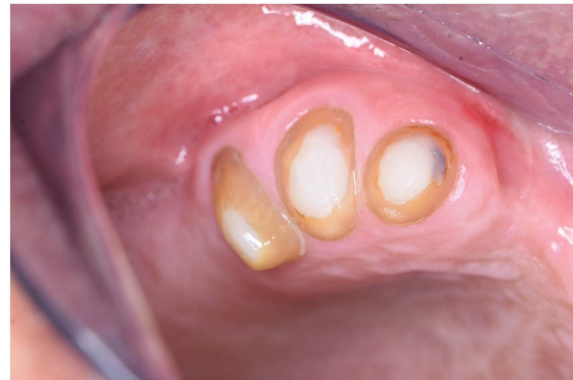
After one month, the patient was recalled for further treatment. Teeth 12, 13, and 14 were prepared as a dome shape for metal coping using crown preparation burs (Fig. 6). An impression of the prepared teeth was taken using putty and light body addition silicone (Elite HD+ Putty Soft and Light Body, Zhermack). A diagnostic wax-up was done on the lower cast (Fig. 7). The vertical amount of coronal reconstruction in the diagnostic wax up was 1 mm which was decided based on the preoperative vertical dimension at occlusion (VDO) measurements that indicated an increase of freeway space due to generalised attrition.

Fig. 6 Teeth 12, 13, and 14 were prepared to receive coping.

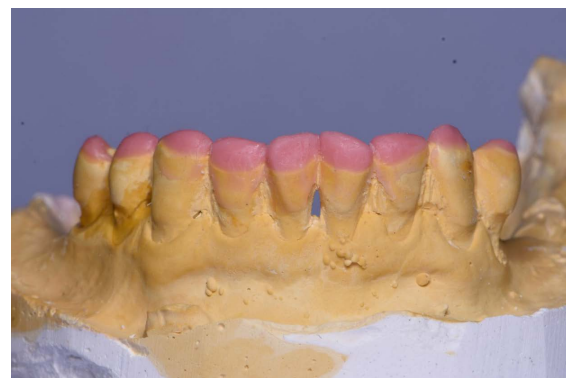
Fig. 7 Diagnostic wax-up of the lower cast.

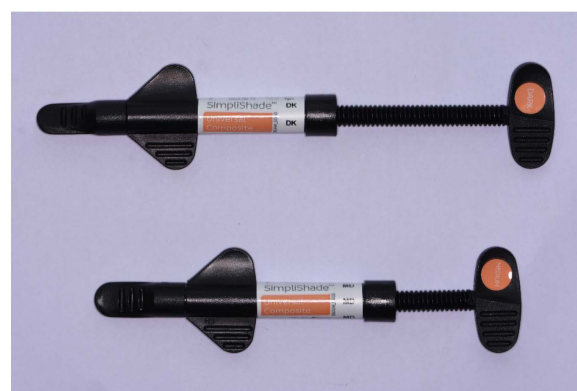
The patient came for lower anterior composite build-up to replace missing tooth structure and diastema closure on teeth 34 to 45 using medium and dark shade composite (SimpliShade™ Composite, KaVo Kerr, Germany) (Fig. 8). Teeth 34 to 45 were beveled, and sharp edges were removed prior to composite restoration (Figs. 9A and 9B). Medium and dark shades were chosen to match the future denture acrylic tooth shade which is A3, as the original tooth shade was C3 (Figs. 9C to 9H). Glass ionomer cement (GIC) (GC Fuji 2, GC) was used to restore the abrasion of teeth 44 and 45, while medium-shade composite was used for tooth 34. Metal coping was cemented with self-adhesive resin cement (RelyX™ U200, 3M) (Fig. 10).

Fig. 8 Medium and Dark shade SimpliShade™ universal composite used for the anterior build-up.

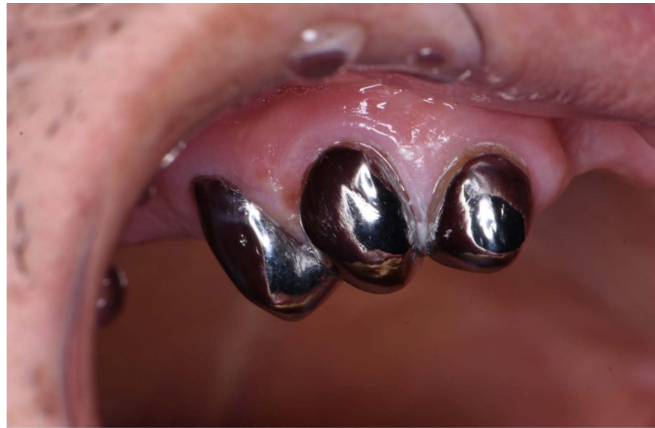
Fig. 10 Post cementation of metal copings onto teeth 12, 13, and 14.
