Original Article

Assessment of microleakage of few restorative materials after erosion by acidic solution

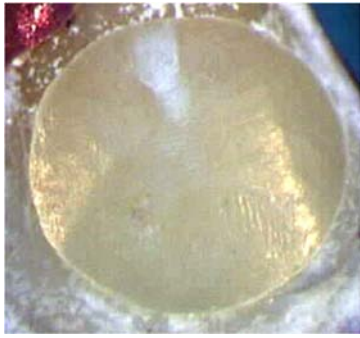
(a) Filtek Z250

Figure 1 Surface photo of the restoration materials, (a) Filtek Z250, (b) Fuji IX, (c) Fuji II LC and (d) Silverfill amalgam after immersion in acidic solution (i) test sample; (ii) control sample.

From the observation of the photos taken after 24 hours exposure to lemon juice, Fuji IX was obviously eroded (Figure 1b). Other materials tested did not show significant changes (Figures 1a, 1c and 1d). Side views for all materials were
