## 种植修复体机械并发症的原因、预防及处理

【摘要】 种植修复体常见的机械并发症有基台或螺丝松动、基台或螺丝折断、支架或种植体折断、修复体崩瓷、修复体固位丧失(失粘接)等。本文将种植修复体分为: 种植体支持的单冠、种植体支持的多单位桥、种植体支持的全口固定义齿三类, 并对2000年后发表有关种植机械并发症的临床文献进行总结归纳。分别对基台或螺丝松动、基台或螺丝折断、种植体折断、修复体崩瓷、修复体固位丧失(失粘接)等各种机械并发症的原因、预防及临床处理进行详细的分析, 旨在减少临床种植修复机械并发症的发生, 为种植修复治疗提供临床指导。

**Technical complications associated with implant prostheses in terms of reason, prevention, and management**  
SHI Bin, WU Tao. Department of Implantology, School & Hospital of Stomatology, Wuhan University, Wuhan 430079, China

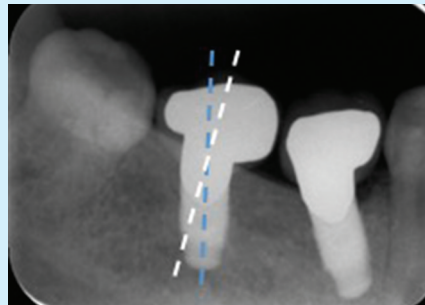
图6 种植体长轴方向与牙冠长轴方向不一致

Figure 6 Different axial direction of implant and prosthesis

在给上部修复体预加扭矩前,应当确认修复体完全被动就位;使用厂家推荐的扭矩对螺丝进行拧紧;减小种植体轴向与咬合力方向的角度偏差(图6);若多次出现螺丝松动,则应更换螺丝;调整咬合避免修复体承受过大咬合力<sup>[38]</sup>。
