## High Velocity Injury And Fracture Of Previously Reconstructed Limb Salvage Tumor Surgery – Options Of Surgical Treatment

<sup>1</sup>Orthopedic Department, School of Medical Science, Universiti Sains Malaysia

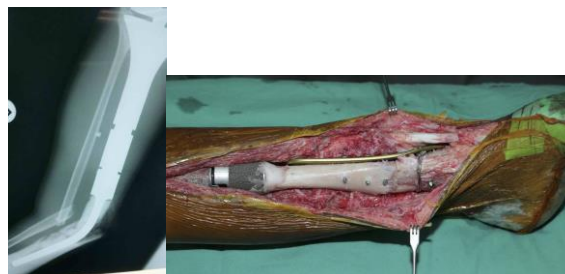
All the fractures involving lower limbs in 3 patients, and upper limb in 1 patient were caused by MVA. 1<sup>st</sup> patient had previous proximal tibia osteosarcoma. He sustained an open fracture of tibia which caused bending of the endoprosthesis stem. He was initially treated with debridement. The comminuted distal tibial fracture was replaced with allograft to allow fitting of a new distal stem.

2<sup>nd</sup> patient with previous proximal humerus Giant Cell Tumour had replacement surgery with endoprosthesis. He sustained comminuted humerus fracture over the stem, which caused implant instability. The construct was revised with a longer implant body segment and a new stem.

3<sup>rd</sup> patient was another proximal tibia osteosarcoma survivor who underwent proximal tibia endoprosthesis but complicated with delayed infection. The implant was removed and he was planned for two-staged endoprosthesis revision. However, an accident caused femur fracture around the proximal part of the temporary bone cement spacer. He was then treated with removal of the spacer and a knee fusion surgery using vascularized fibula graft.

4<sup>th</sup> patient, a case of distal tibia osteosarcoma was initially managed with allograft-vascularized fibula composite ankle fusion. Following an accident, the distal tibia reconstruction was fractured. He was managed with an angular-stable plate fixation.

Bone fracture around a well-fitted massive endoprosthesis might cause severe bony comminution. It is difficult to achieve osteosynthesis in this area. Therefore, the comminuted bones are removed and a new segment of longer implant is used as described in the 2<sup>nd</sup> case. Allograft had been used in the 1<sup>st</sup> case to increase the length of intramedullary canal as the remaining bone was not adequate for the stem. Definitive surgical management was delayed for 3 weeks in the case of open fracture to minimize the risk of infection.

Management of the 3<sup>rd</sup> patient posed another challenge as he already had implant-related infection, a previous proximal tibia resection and a distal femur fracture. Extended revision of distal femur and proximal tibia contributed to difficult soft tissue control for the patient and always complicated with poor outcome. As such, we opted for knee fusion surgery. Reconstruction with vascularized fibular graft has an advantage of biological healing in combating the infection, as well as providing stable limb for ambulation.

4<sup>th</sup> patient had a fracture of his allograft-fibula composite reconstruction, which was a biological construct and had a potential for osteosynthesis. We used Locking Compression Plate (LCP) through minimally invasive surgery to minimize the soft tissue stripping over the flap while maintaining vascularity for better healing.
